# GROUND WATER INVESTIGATION

San Mateo Creek Basin Uranium Legacy Site

Characterize ground water quality and impact by legacy uranium mining and milling activities

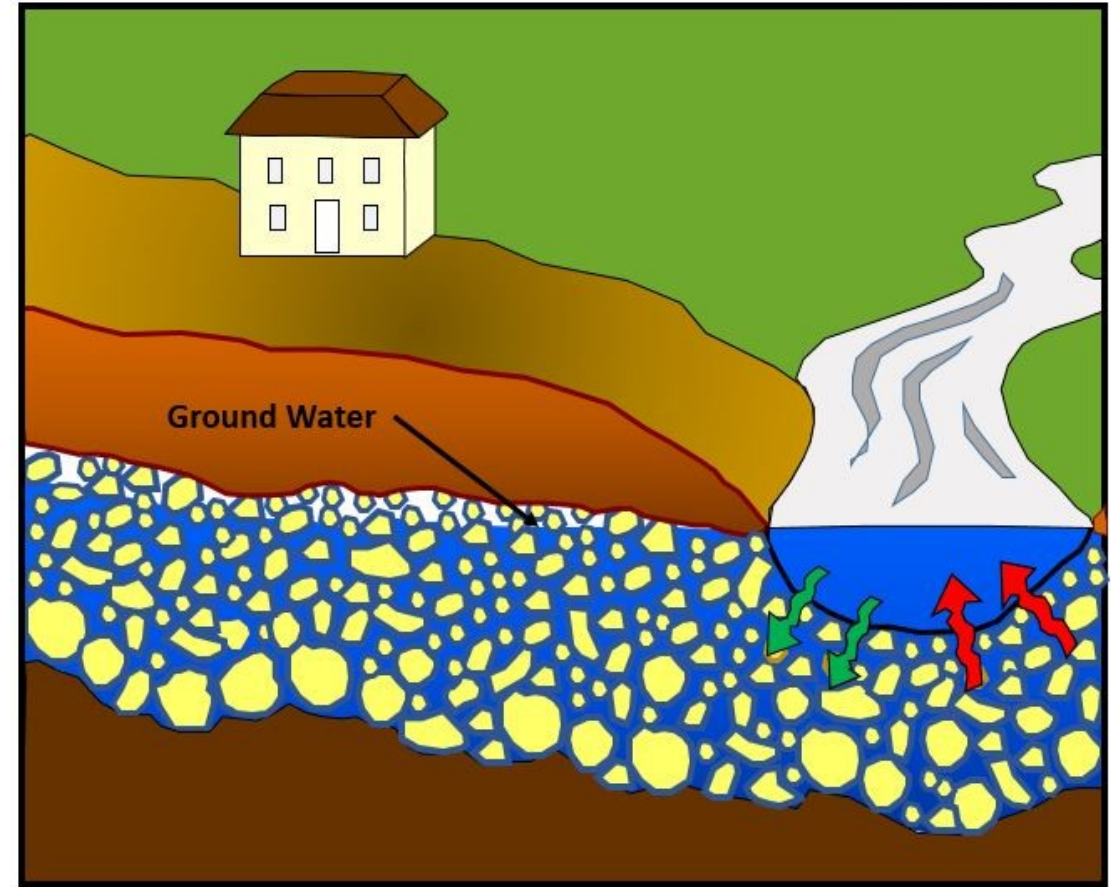
# WHERE IS THE GROUND WATER?

- Alluvial Ground Water
  - Shallow ground water
  - At depths reaching about **120 feet** below ground surface
  - In sediments at base of drainage channels (arroyos, creeks)
- Bedrock Ground Water
  - Deeper ground water
  - Hundreds of feet below ground surface
  - In rock formations

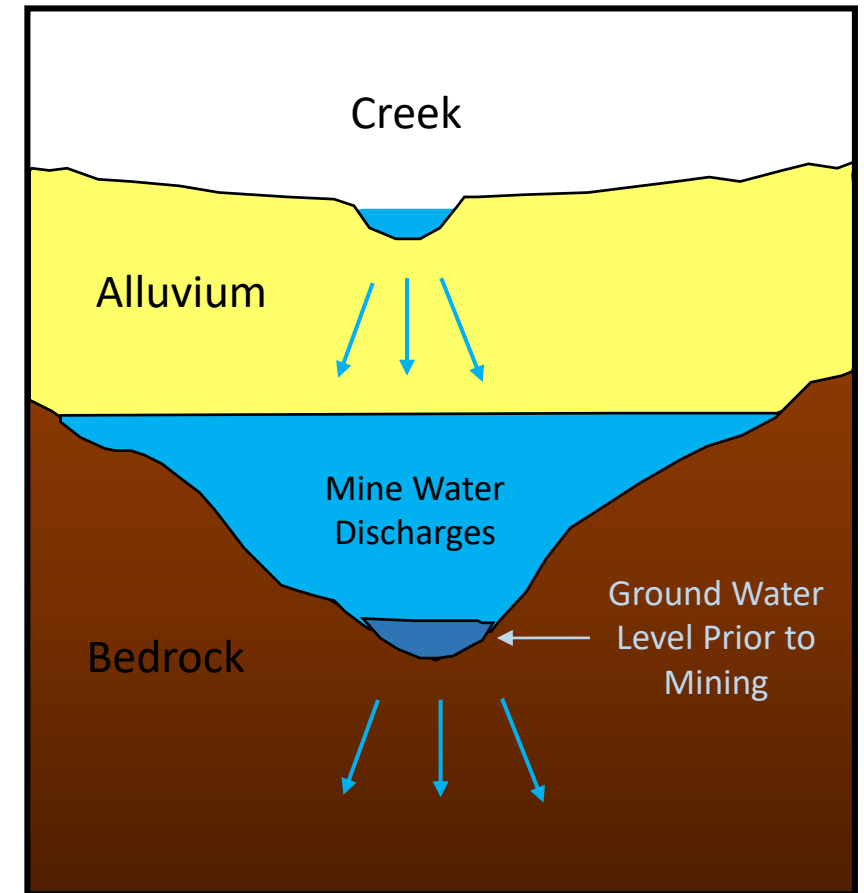
# HOW DID MINING OPERATIONS AFFECT GROUND WATER?

- ***Discharged billions of gallons*** of mine water to creeks and arroyos
- ***Water infiltrated*** into ground
- ***Increased amount of ground water*** in alluvial sediments and bedrock
- ***Changed quality*** of ground water

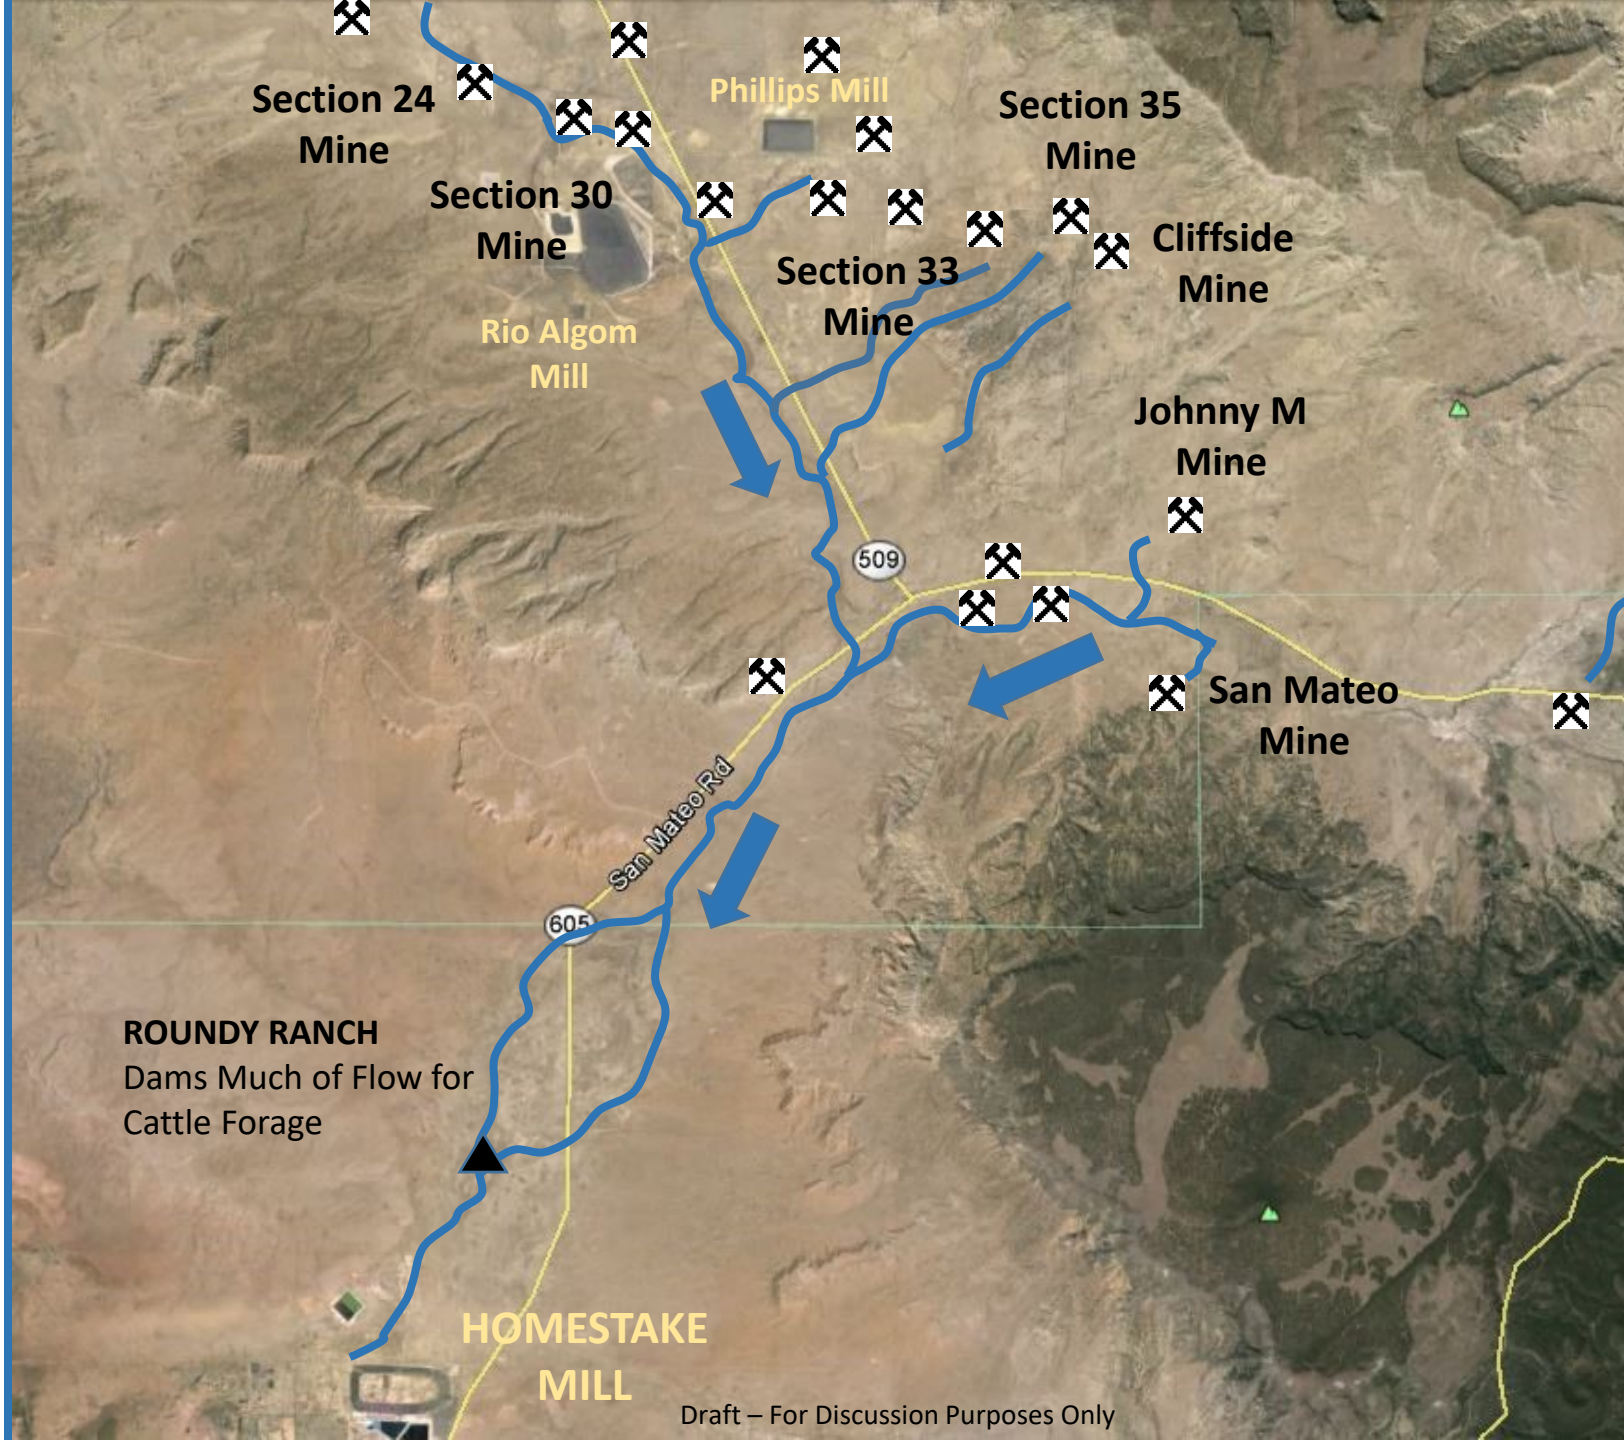
# MINE WATER DISCHARGE

Artificially  
Created Flows in  
Arroyos

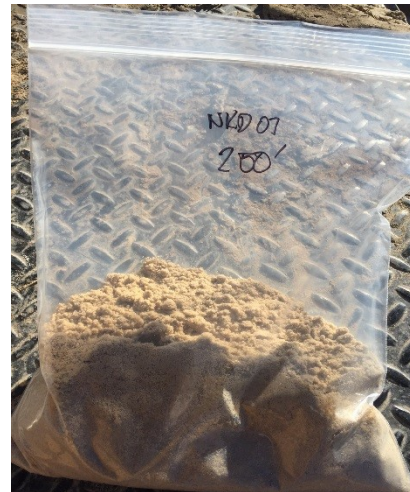
Wet Alluvial Sediments

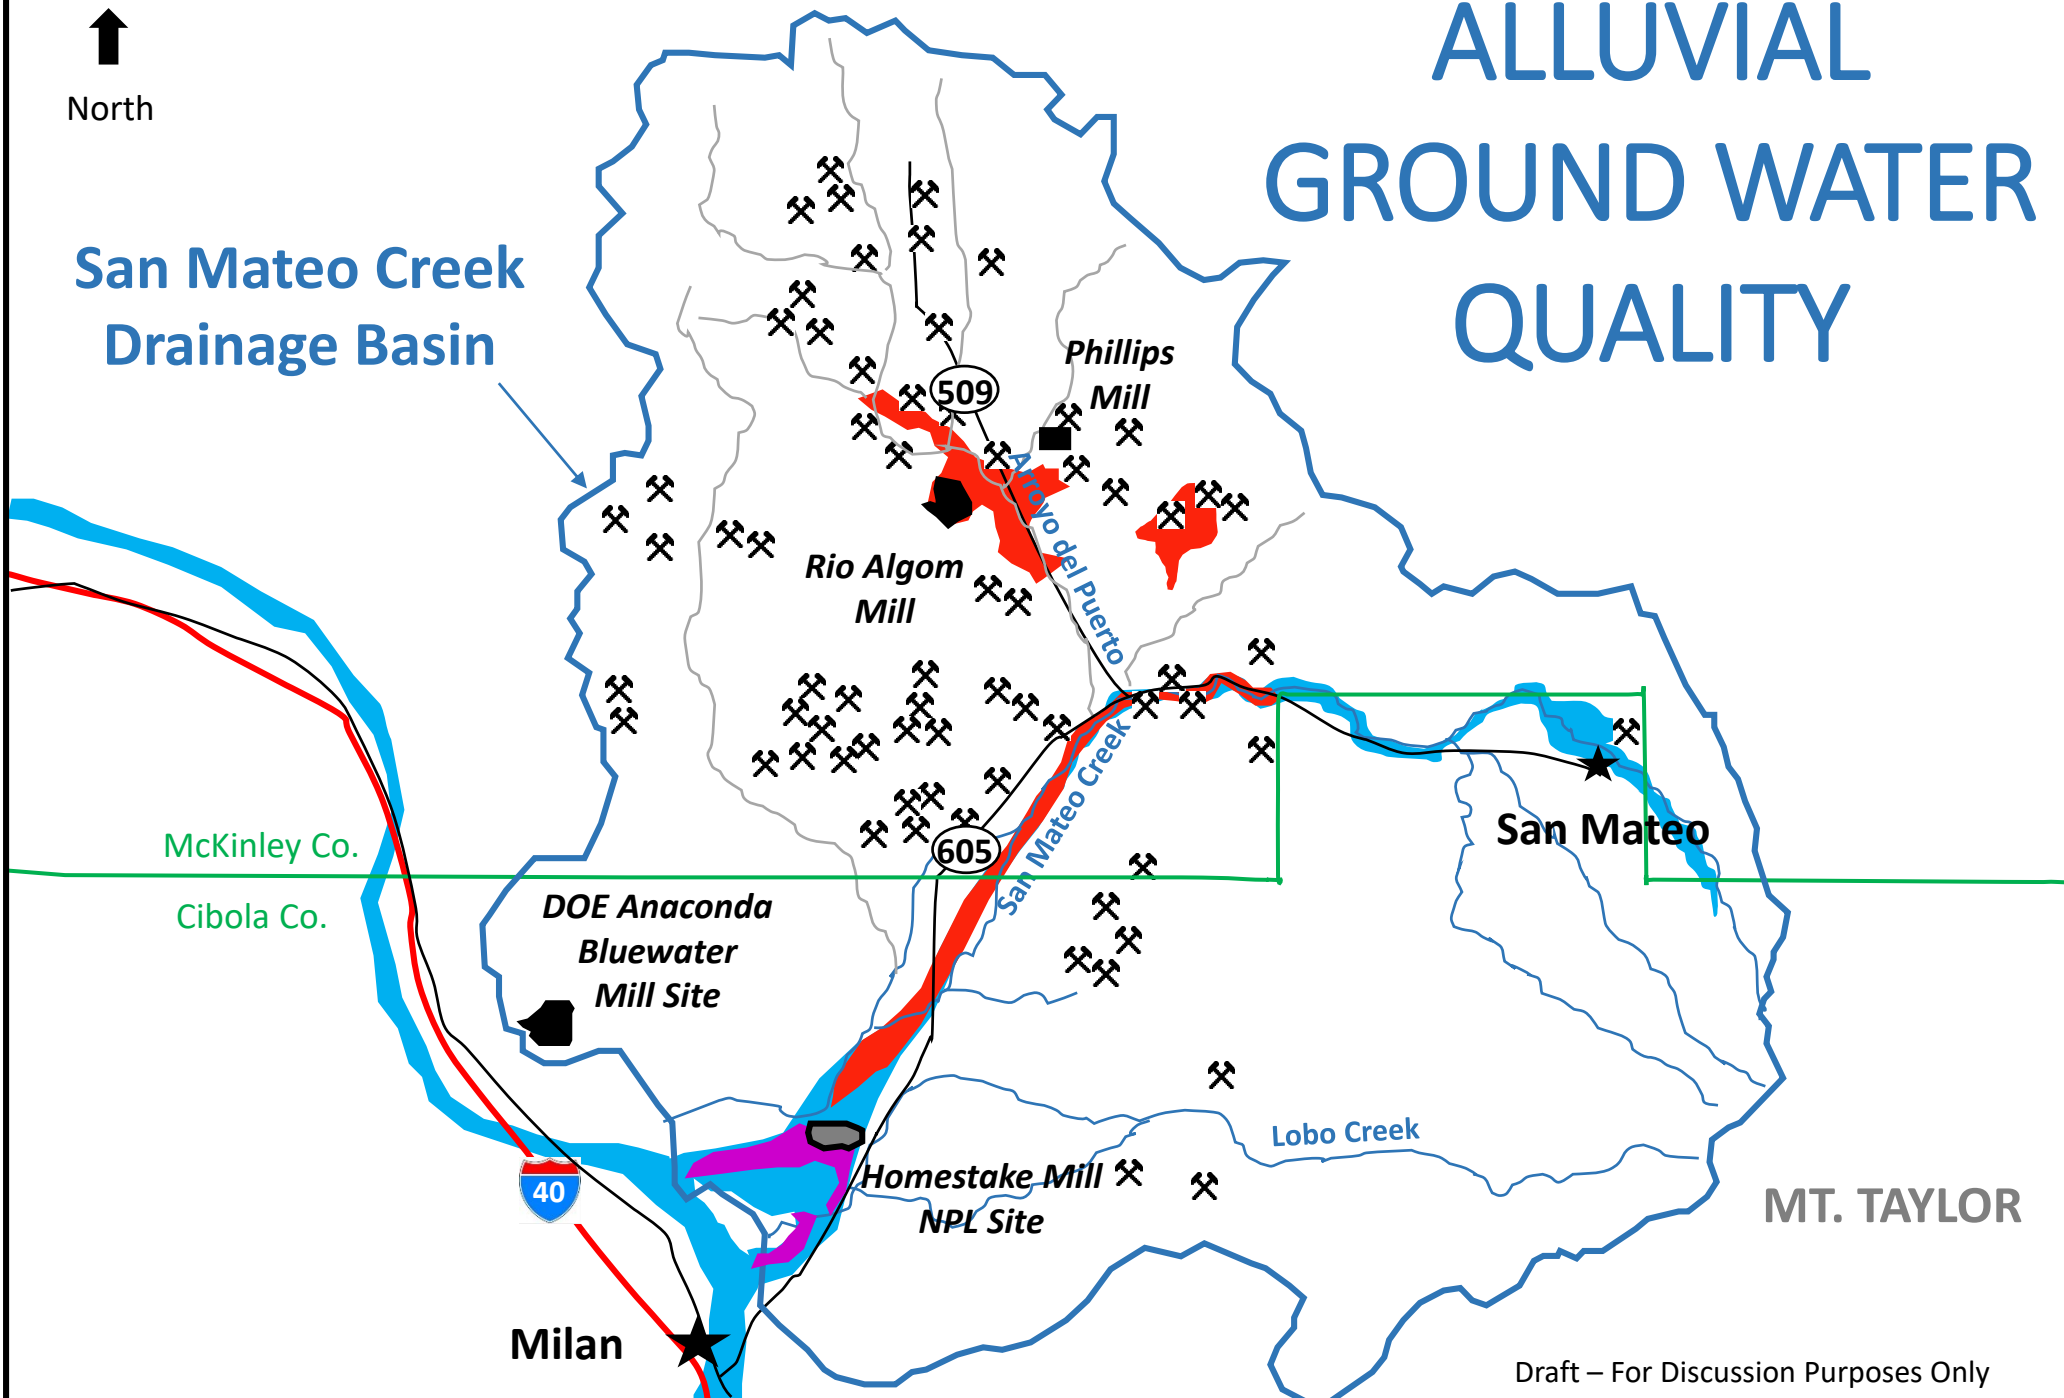
# ALLUVIAL GROUND WATER QUALITY

Alluvial Ground Water
-   Poor Alluvial Water Quality (Exceeds Standards)
-

Poor Alluvial Water Quality Contaminated by Homestake NPL site (Exceeds Standards)

- Attempt to Characterize Alluvial Water Quality had **Mixed Results**
  - Lack of Natural Saturation in Many Areas Investigated
- Alluvial **Water Quality Varies** Across Basin
  - Good quality upgradient of mines and mills
  - Poor quality downgradient of mines and mills
- Mine Discharge Water **Increased Saturation** in Alluvium
- Mine Discharge **Water Draining Out** of Alluvium Today

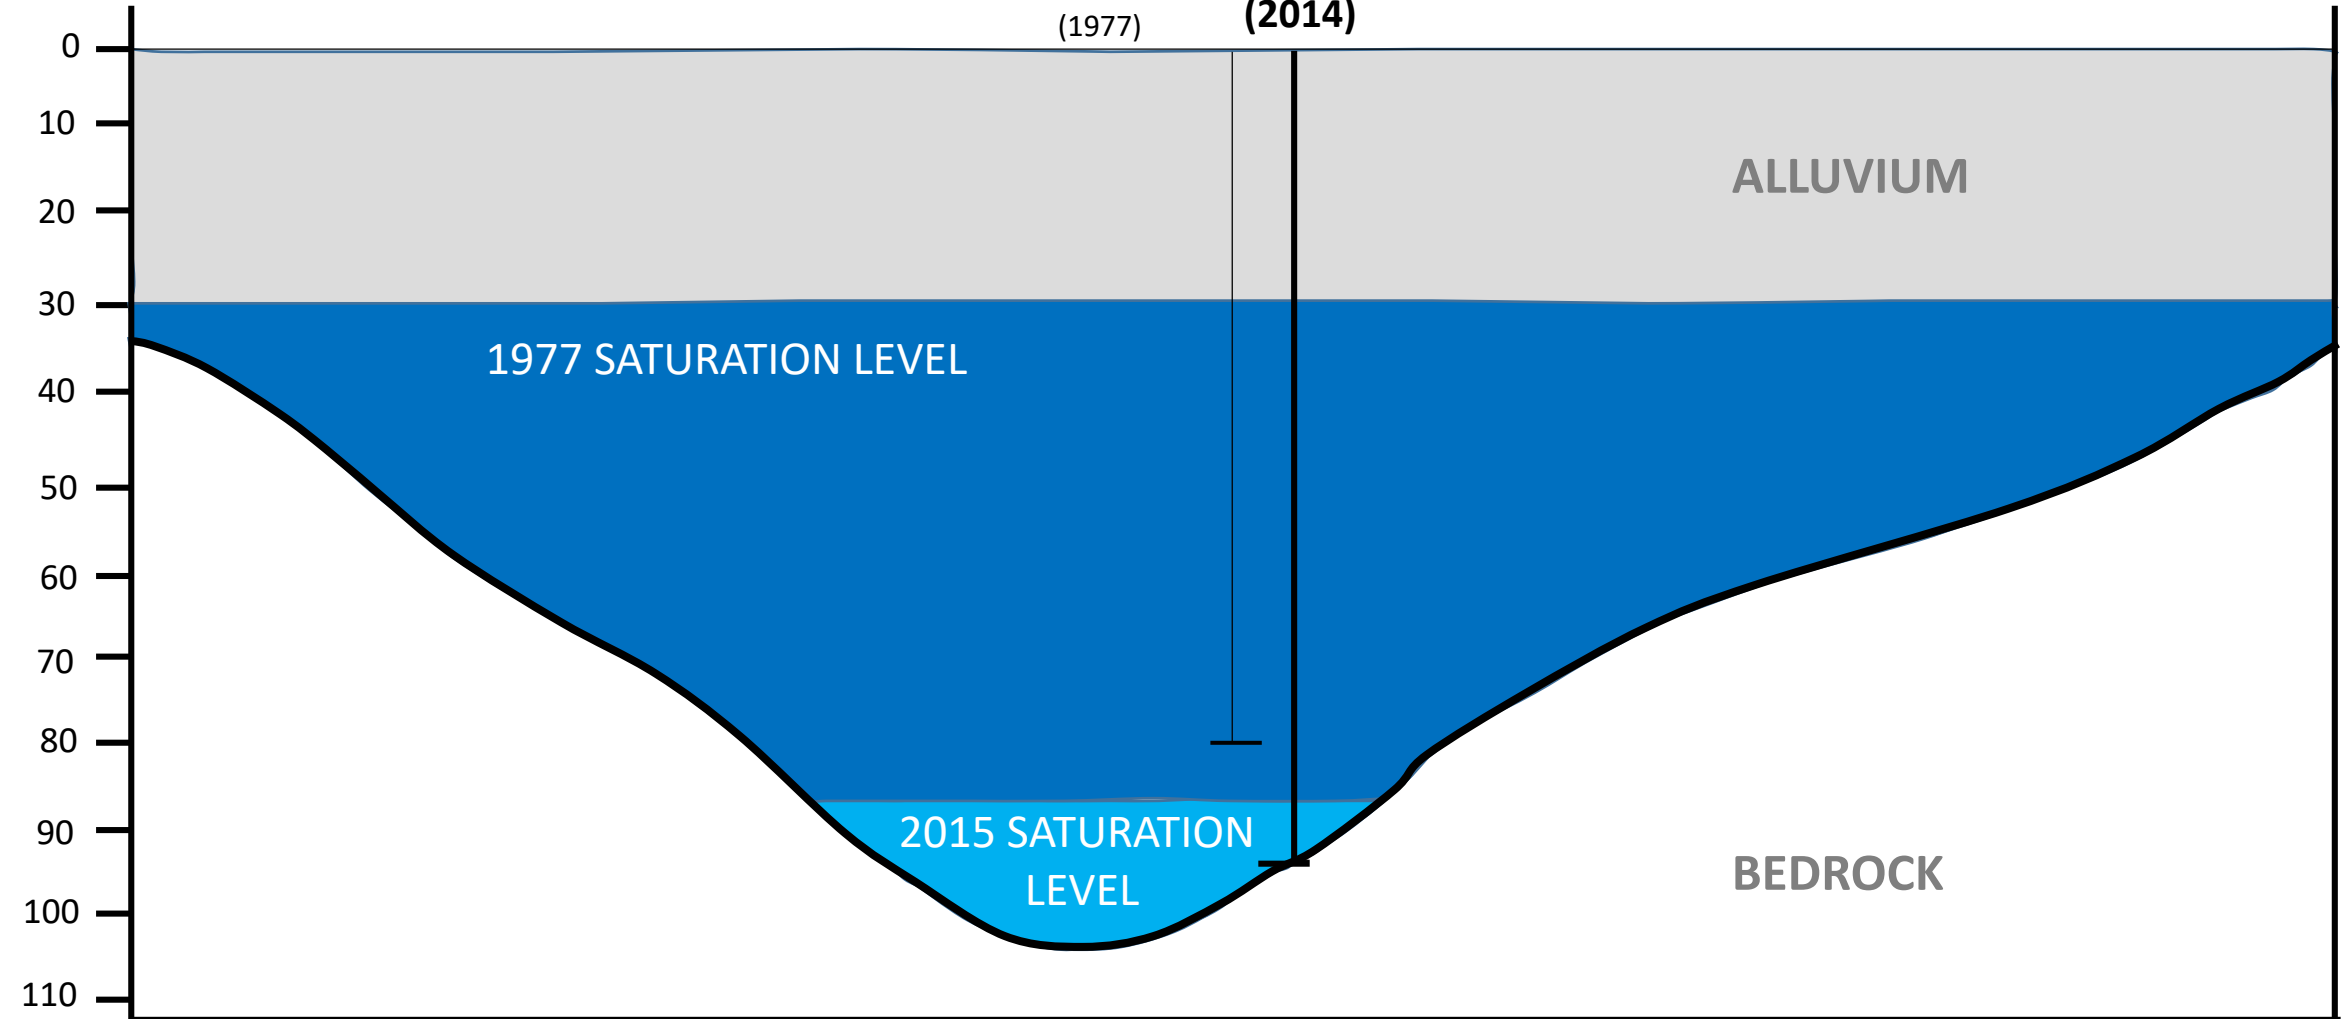
# CROSS SECTION A-A'

## CENTRAL SAN MATEO CREEK BASIN AREA

West

East

Depth  
(ft)

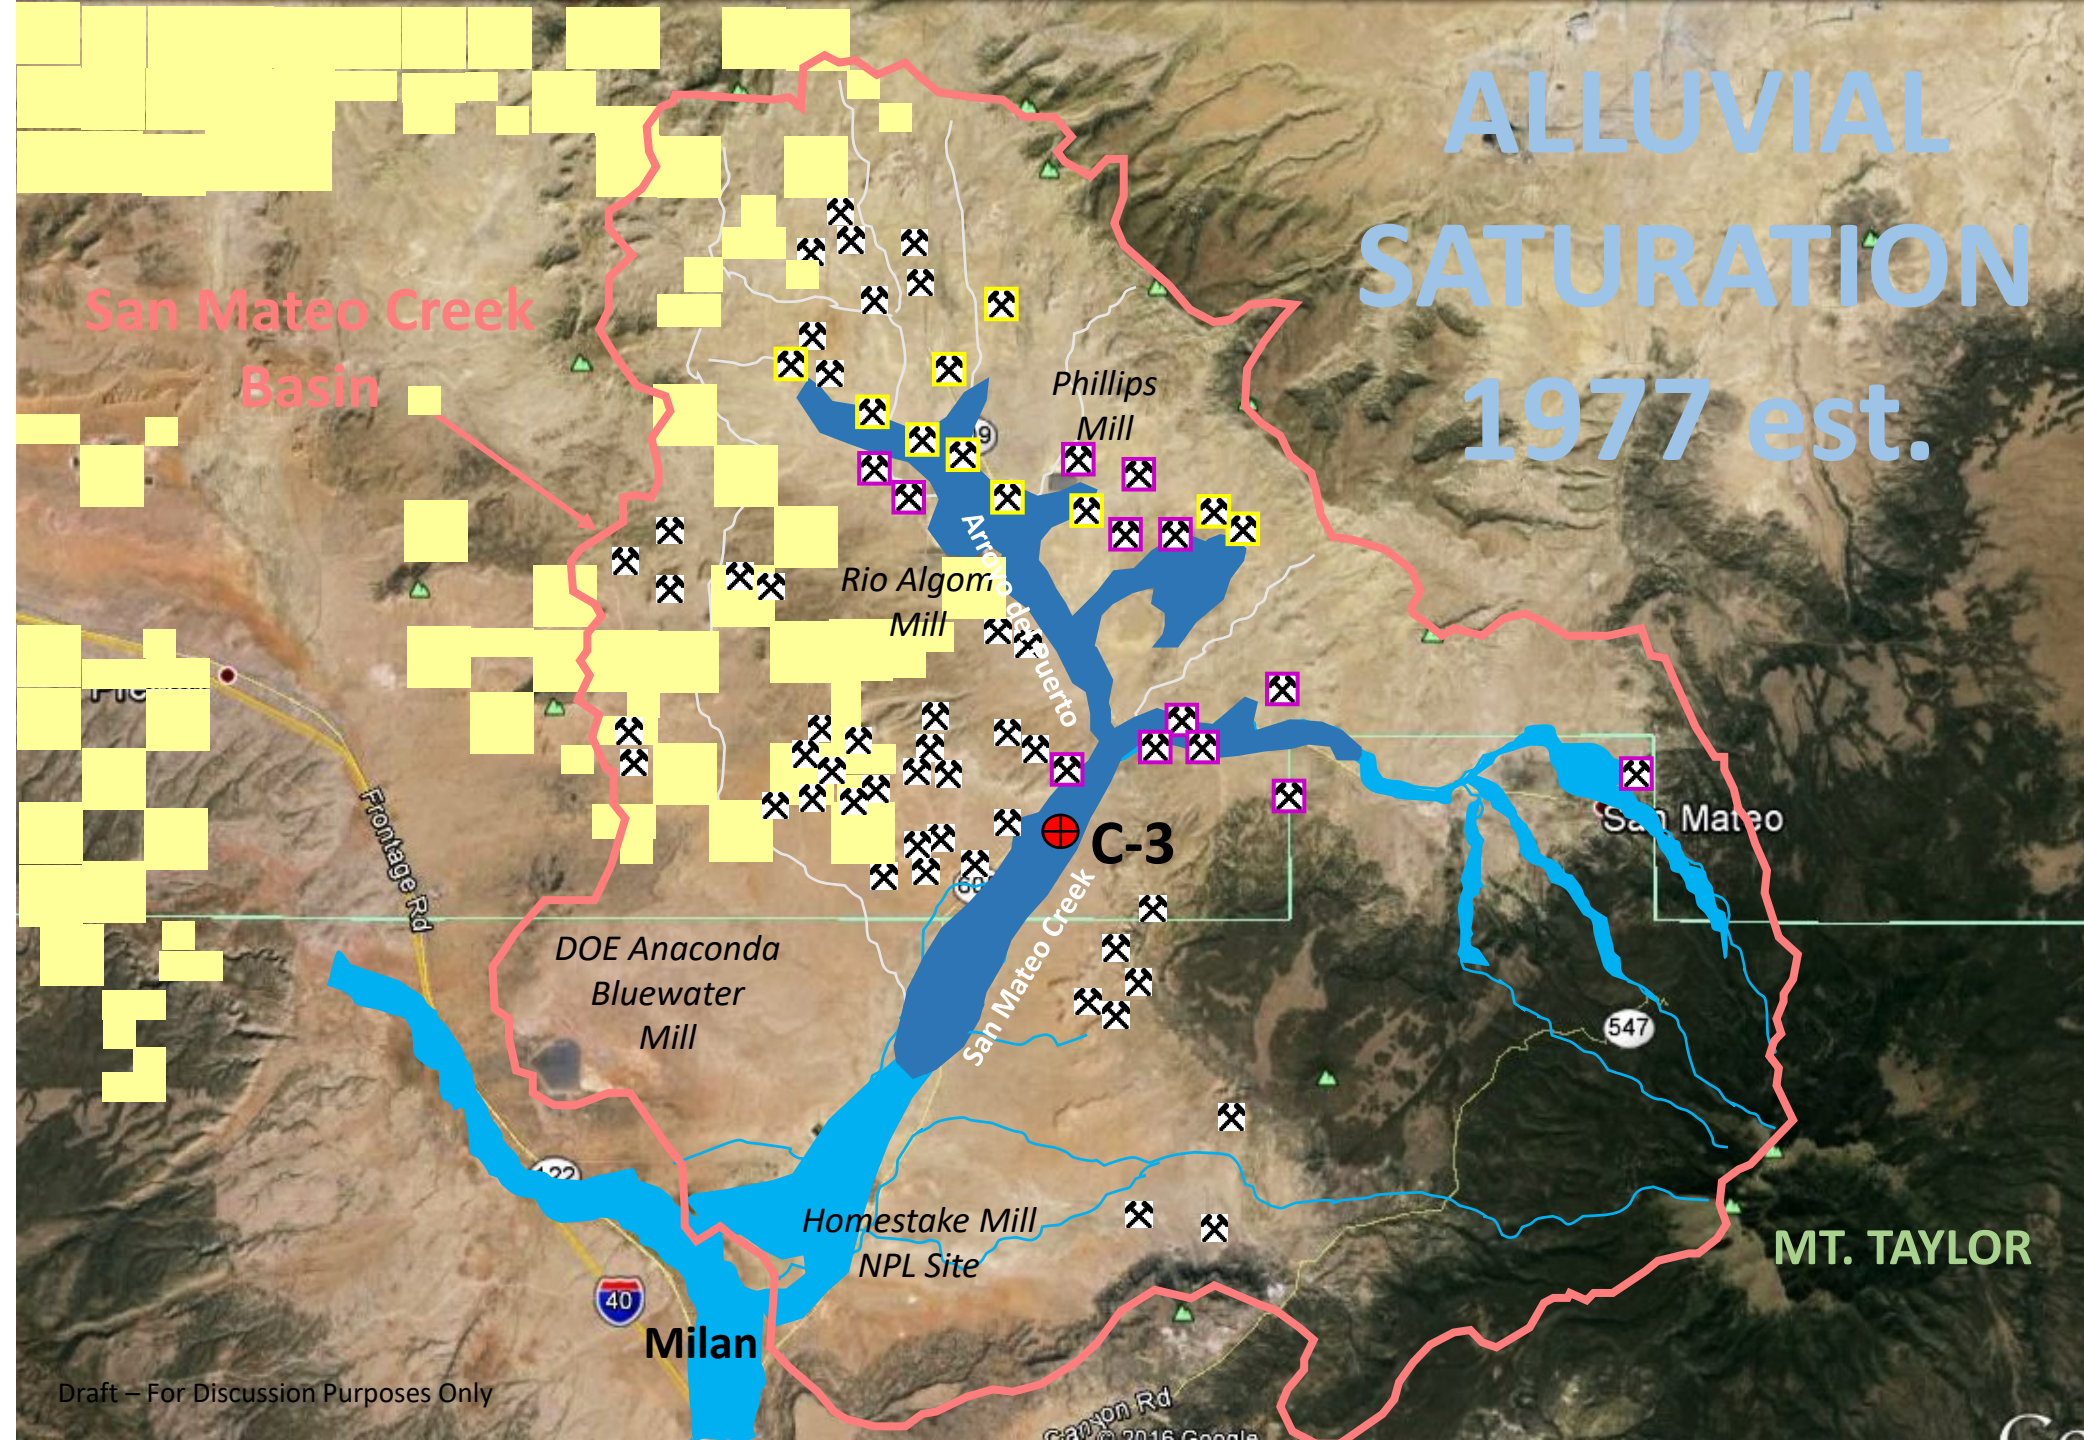
# ALLUVIAL SATURATION 1977 est.

San Mateo Creek  
Basin

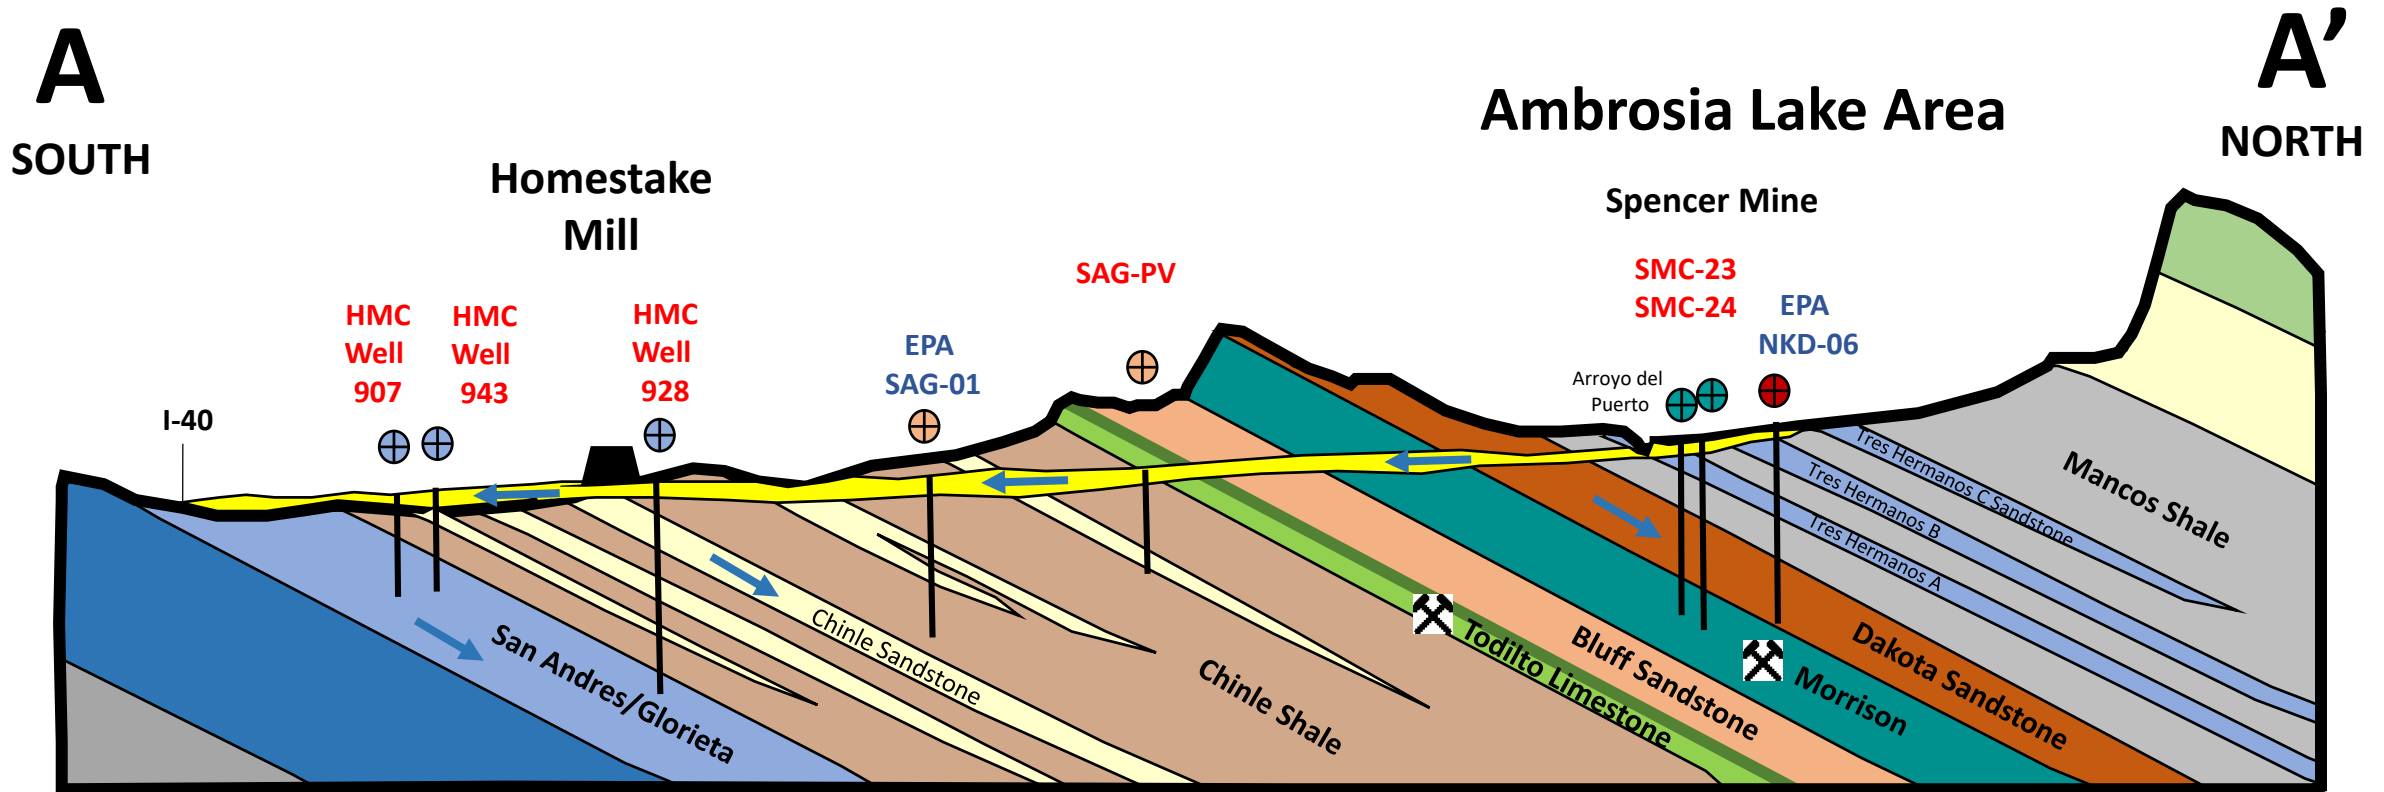
# CONCEPTUAL SITE GROUND WATER MODEL

## Generalized Cross Section Through San Mateo Creek Basin

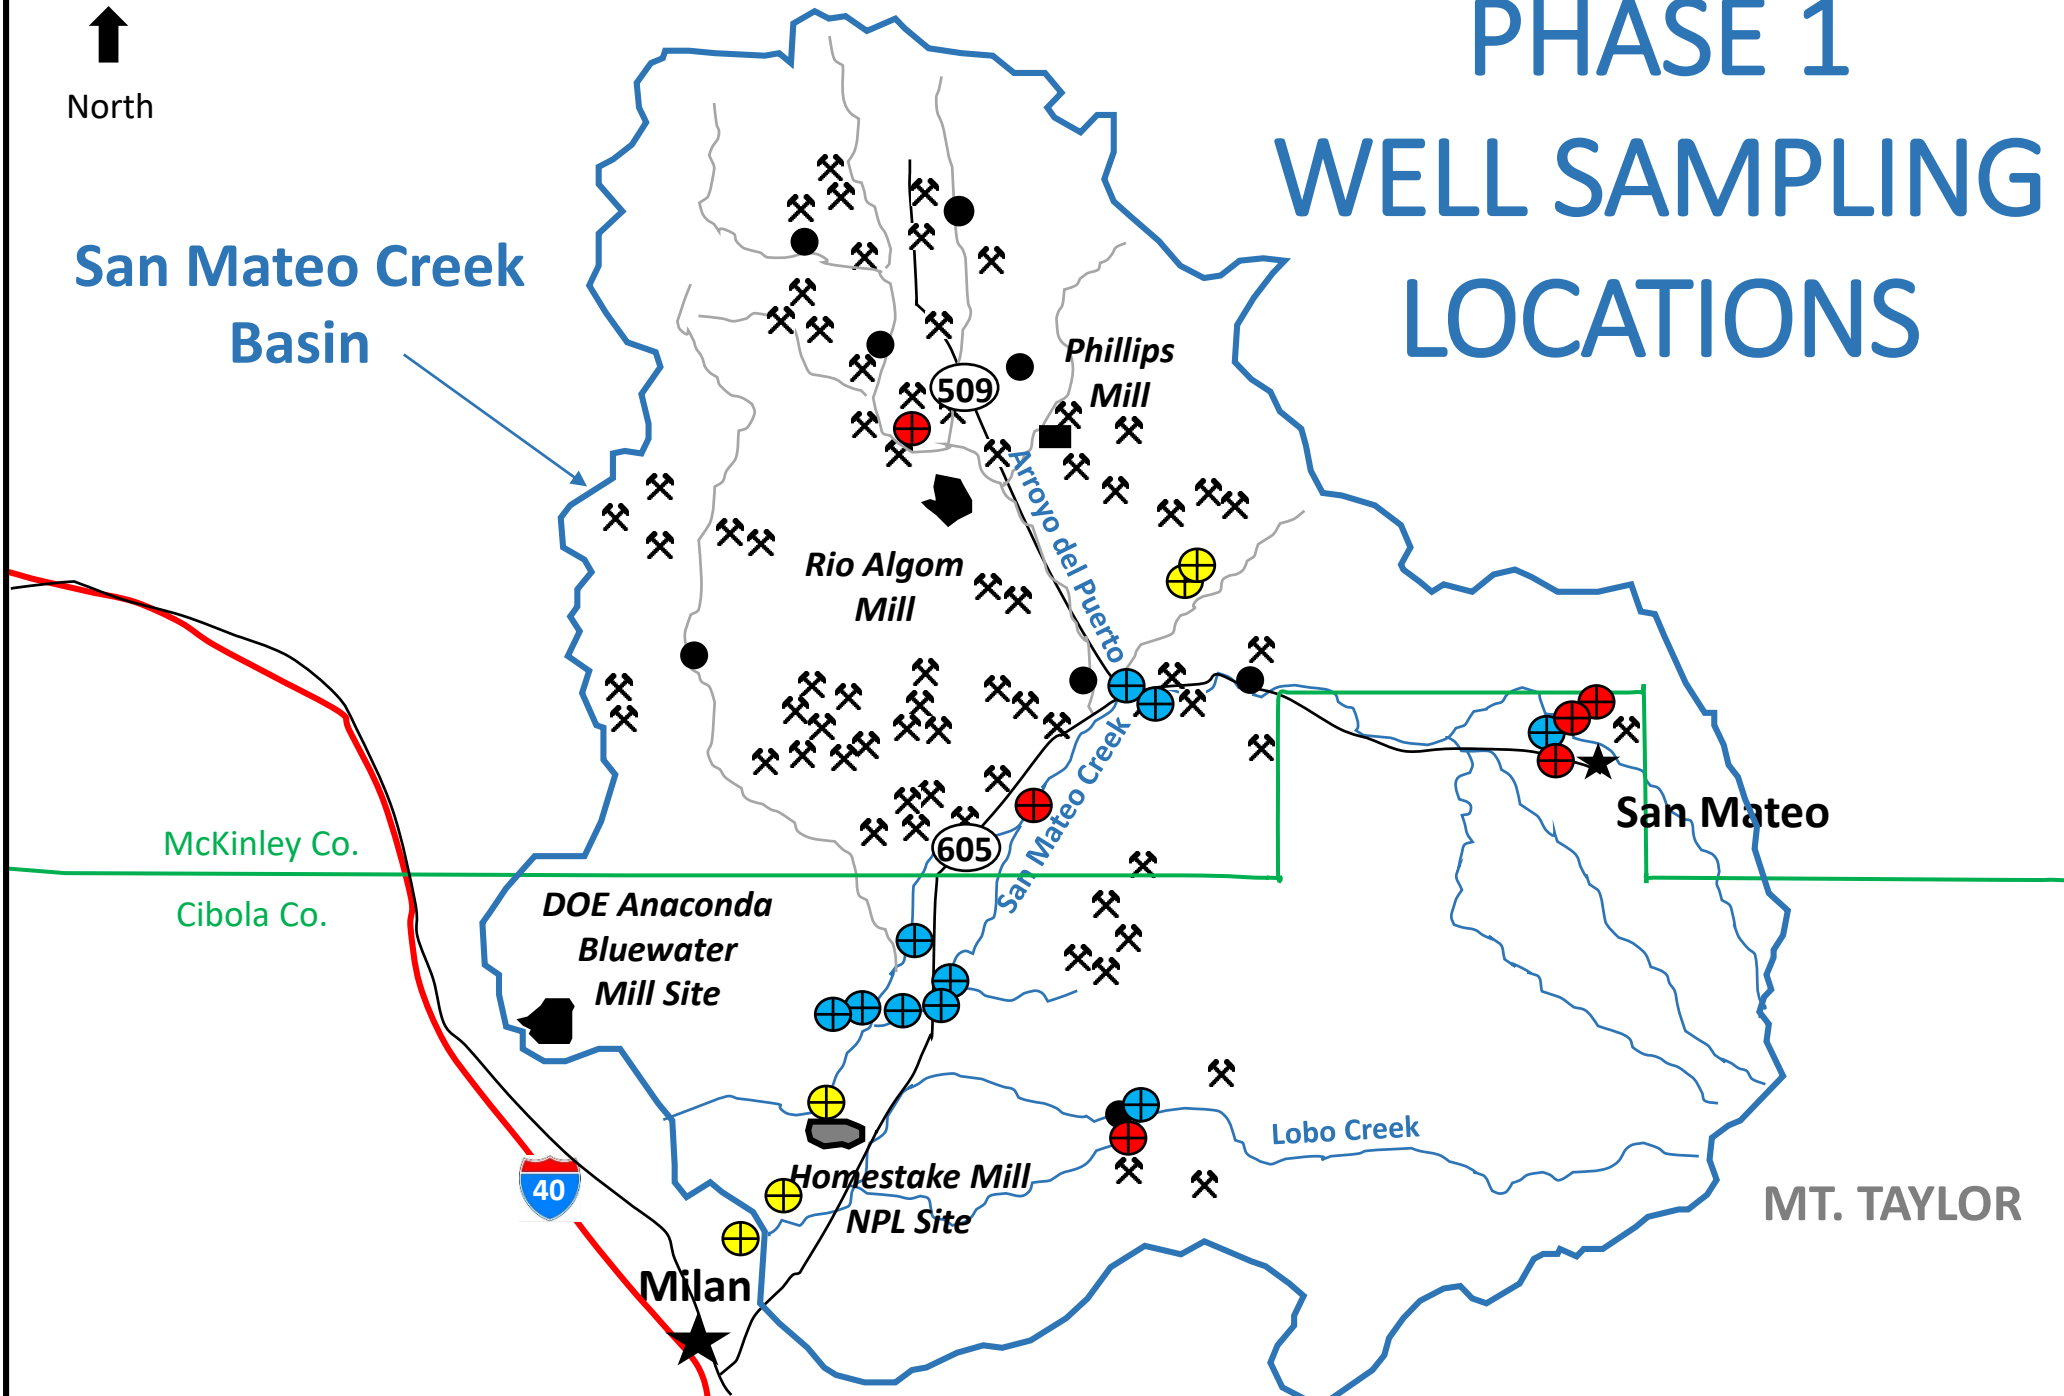
# PHASE 1 WELL SAMPLING LOCATIONS

EPA Alluvial  
Monitoring Well
-

Industry  
Monitoring  
Well
-

Private Well
-

Dry Borehole

- 30 Boreholes Drilled
  - 6 monitoring wells installed where water encountered
  - 24 boreholes dry
- 15 Existing Wells Sampled
  - 10 private wells
  - 5 industry monitoring wells
  - Includes both alluvial and bedrock wells

- All 10 private wells exceeded standards
- Only 3 of 10 wells used for drinking water supply
- Only 1 of the 3 exceeded drinking water standards
- Point-of-Use Treatment Systems installed by EPA at home exceeding standards
